# Tangier Island Bridge

Tangier, Virginia

North Star Construction Corp. was awarded the contract for replacement of the bridges. It contracted Bayshore Concrete Products in Cape Charles, VA, to produce two abutments for one of the bridges.

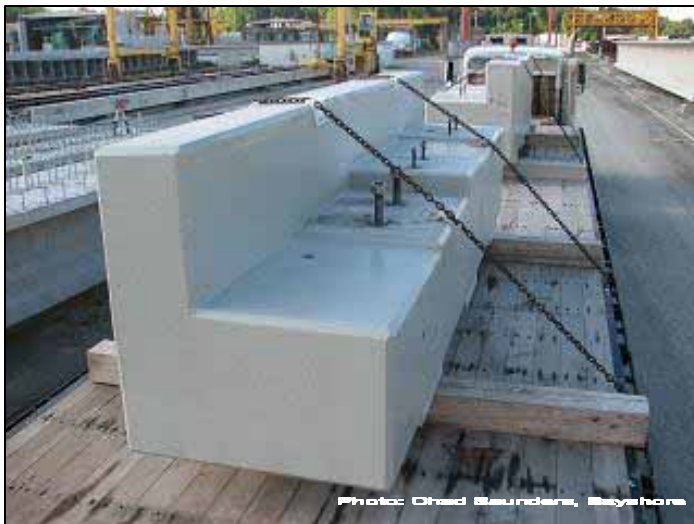
Precast abutments shipped from Bayshore facility to Tangier Island.

By precasting the abutments, the contractor was able to ship the bridge components by barge to Tangier Island and place them into position, without incurring the costs of on site cast-in-place construction. From beginning to end the entire prefabrication job took 14 days. A purchase order was received on April 11 and the welded cages were on a truck and for delivery to Bayshore by April 25, 2006.

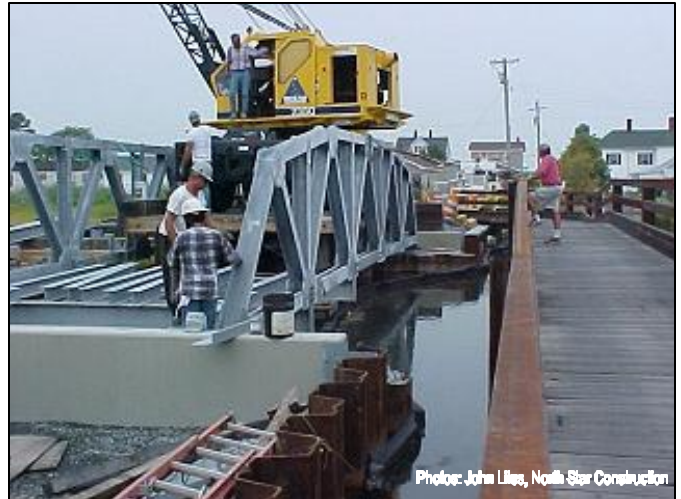
Specially designed superstructure placed on precast abutments with pre-welded stainless steel reinforcement.
